# Manhole Inspection Summary

Manhole # S3101\_012MH

Insp Date: **2/8/08 10:46 AM**

**Location** Address: **644 Cherrycrest Rd**

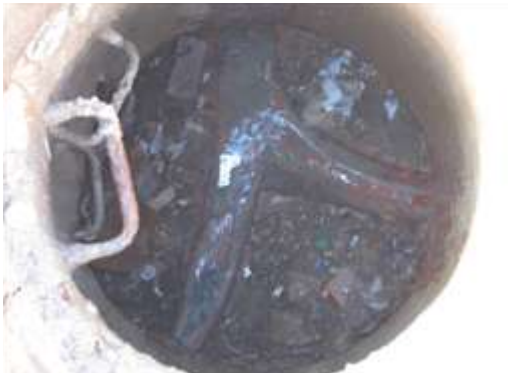
**Steps** Count: **4** Missing: **0** ☒ **Corroded**

Steps

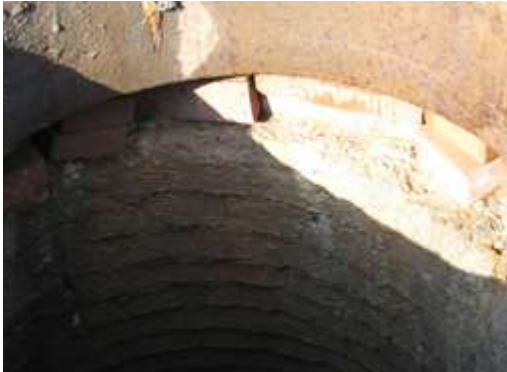
Defect 1

**Frame** Offset: **2.5** (in.) Condition: ☒ Sound ☐ Cracked ☐ Leaks

Frame offset

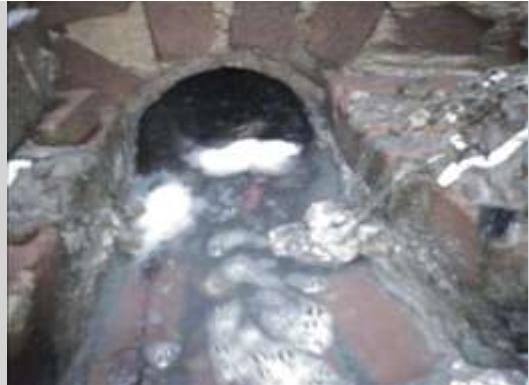
12 O'Clock Outflow

8 in. Circular Gravity Sewer  
Pipe Out @ 12 O'Clock

Pipe Height: **8.4** (in.) Rod and Bar (Angled)  
Pipe Material: **Clay** ☐ Pipe Lined  
Invert Depth: **8.69** (ft.) Flow Characteristics: **Fast**  
Deposits: ☒ None ☐ Mud ☐ Sludge ☐ Debris ☐ Grease  
Silt Depth: (in.) Deposits Extent:  
Infiltration: **None** Pipe Seal Cond: **Sound**

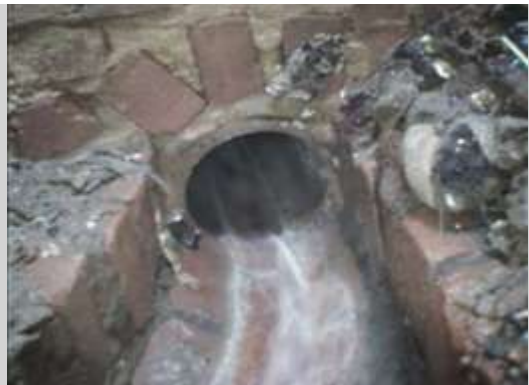
4 O'Clock Inflow

6 in. Circular Service Sewer  
Pipe In @ 4 O'Clock

Pipe Height: **7.2** (in.) Rod and Bar (Angled)  
Pipe Material: **Clay** ☐ Pipe Lined  
Invert Depth: **8.46** (ft.) Flow Characteristics: **Fast**  
Deposits: ☒ None ☐ Mud ☐ Sludge ☐ Debris ☐ Grease  
Silt Depth: (in.) Deposits Extent:  
Infiltration: **None** Pipe Seal Cond: **Sound**

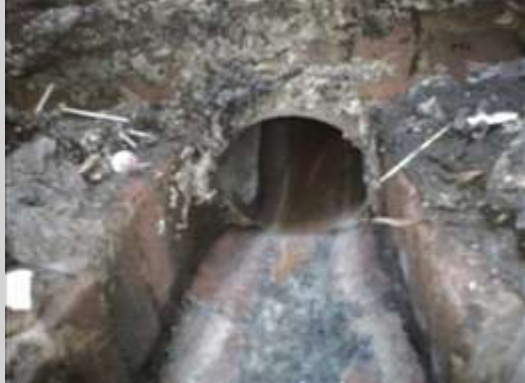
7 O'Clock Inflow

8 in. Circular Service Sewer

Pipe In @ 7 O'Clock

Infiltration: **None** Pipe Seal Cond: **Sound**
